1. Executive Summary

This General Condition Report for the Proposed East Chop Coastal Bank Restoration Project for an engineered coastal bank located along East Chop Drive in Oak Bluffs, MA was prepared by CLE Engineering, Inc. for the Department of Conservation and Recreation (DCR). The report reviews the history of the engineered coastal bank at East Chop along with a tabulation of existing historic work, engineering plans, environmental permits and post-Sandy inspection reports. The existing site conditions were assessed by reviewing historic plans since 1936 and documents along with the performance of topographic surveys, standard penetration tests (SPT) and yearly inspections from 2012 through 2017 and as shown on plans prepared by CLE dated May 25, 2017. The existing coastal bank and stone revetment structure has been downgraded to F-IV from a previously rated D-IV by the Coastal Infrastructure Inventory and Assessment” prepared for the Massachusetts Coastal Hazards Commission by Bourne Consulting Engineering in 2013, recommending reconstruction to regain full capacity to resist major coastal storms and protect vital infrastructure and property. Once the existing conditions

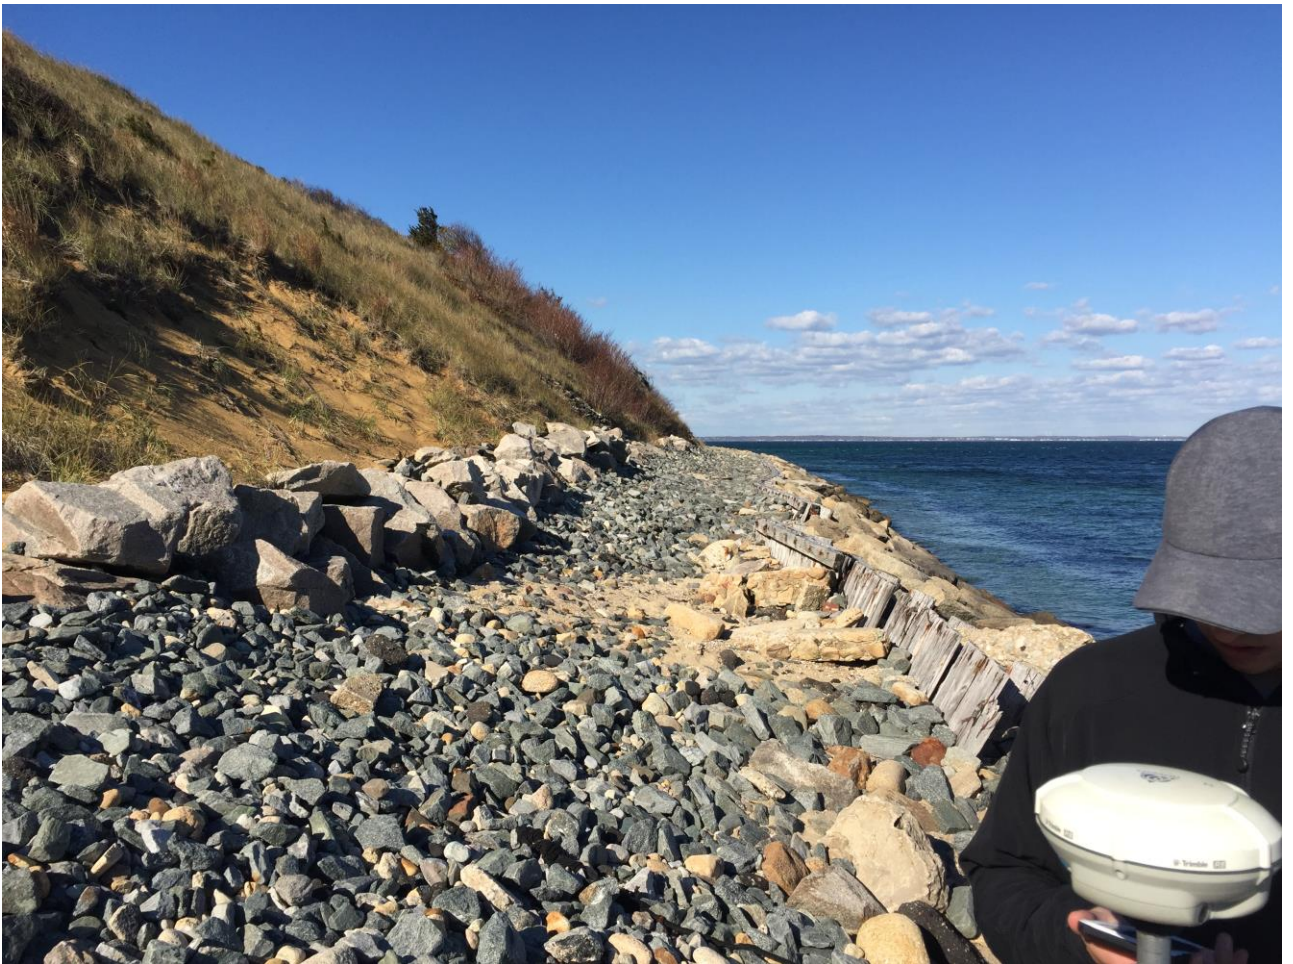
<u>Station</u>	<u>Structure</u>	<u>Material</u>	<u>Length</u>	<u>Cond.</u>	<u>Required Action</u>
0+00	East Chop Revetment	Stone	2,400'	D/F	Reconstruct & Raise to FEMA + 2'

The existing stone revetment is constructed with 2 to 6 ton weathered granite blocks with an imbedded timber bulkhead (circa 1936). The structure is in poor condition (D/F) and is currently unravelling as coastal bank failure dislodge and deform the existing structure. The limited height of the existing stone revetment has allowed storm waves to attack the toe of the coastal bank and destabilize the engineered coastal protection structure.

View North of the Deteriorated Stone Revetment & Eroded Coastal Bank (Typical) in November 2016

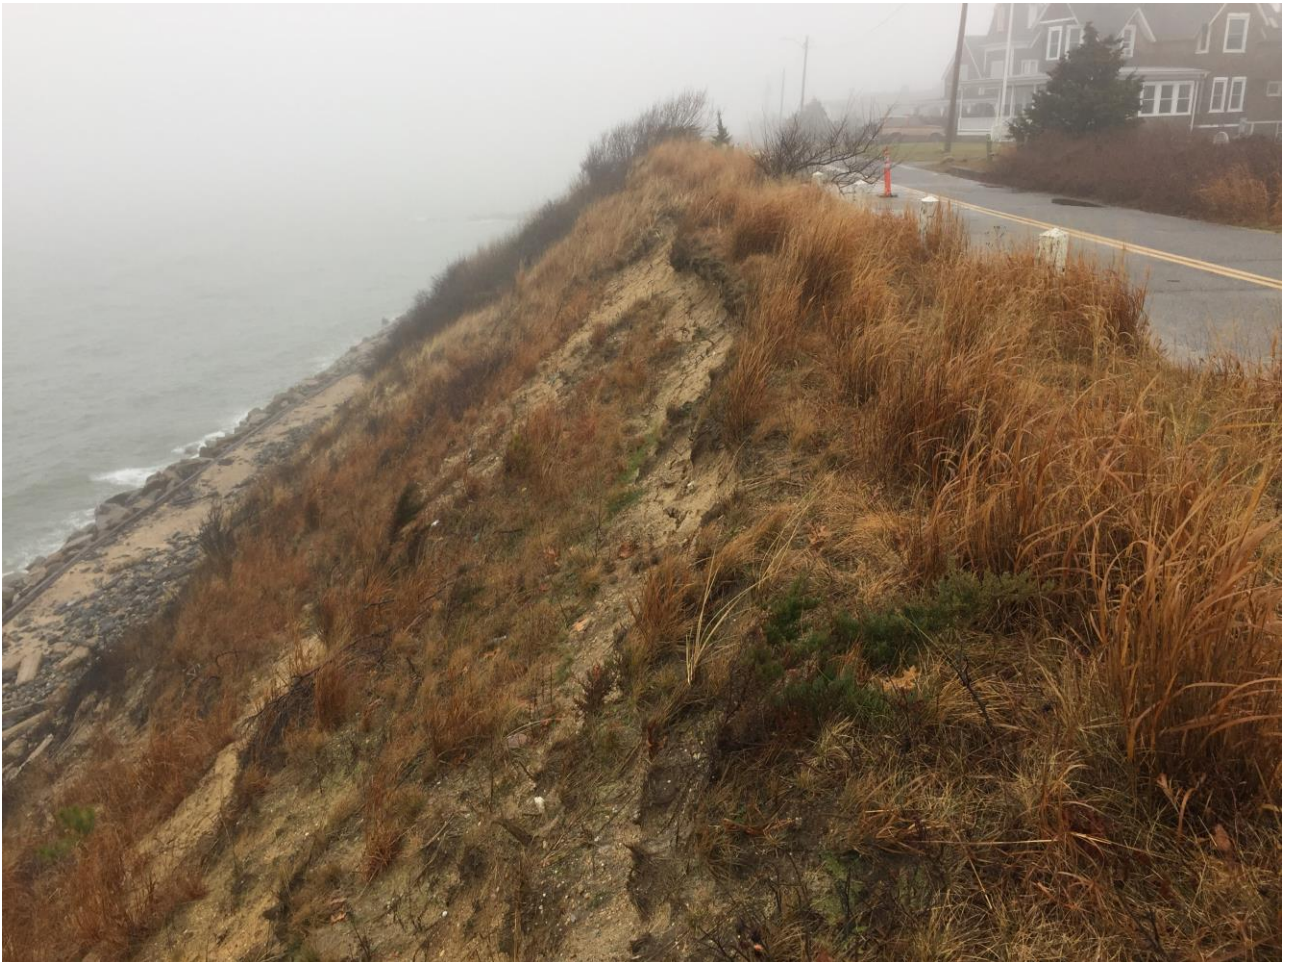
<u>Station</u>	<u>Structure</u>	<u>Material</u>	<u>Length</u>	<u>Cond.</u>	<u>Required Action</u>
0+00	Coastal Bank	Eng. Fill	2,400'	F	Reconstruct w/ veg. 27 deg. slope

The existing engineered coastal bank was originally constructed at a slope of approximately 34 degrees exceeding the fill material angle of repose and has been repeatedly repaired since the 1940's. The coastal bank was partially stabilized by primarily beach grass and other coastal vegetation. The recent increase in storm intensities and waves from the 2012 Super-Storm Sandy over-washed the existing stone revetment washed away and significant section of the coastal bank toe. The undermined toe triggered a series of slope failures and threatened the roadway on East Chop Drive. The Town of Oak Bluffs closed the seaward lane of East Chop Drive in the fall of 2012 and has monitored the slow progression of continuing toe and slope failures with each passing storm. As of March 2017, the failing coastal bank slope had begun to undermine the edge of the roadway pavement.

View South of the Failing Coastal Bank and adjacent roadway (Typical) in January 2017
